**TEST REPORT Nº 096255**

CLIENT	EXPALUM
APPLICANT	JOSE ANTONIO ENRÍQUEZ
ADDRESS	POL. MUNICIPAL, C/COLOMBIA s/n 06360 FUENTE DEL MAESTRE (BADAJOZ)
OBJECT	BIOCLIMATIC PERGOLA ESSAY
MATERIAL TESTED	REF.<<WATERPROOF ALUMINIUM PERGOLA SYSTEM WITH ROTATING LOUVERS>>
DATE OF RECEIPT	29.11.2021
DATE OF TEST	10.01.2022
DATE OF ISSUE	24.01.2022

<<WATERPROOF ALUMINIUM PERGOLA SYSTEM WITH ROTATING LOUVRES>>

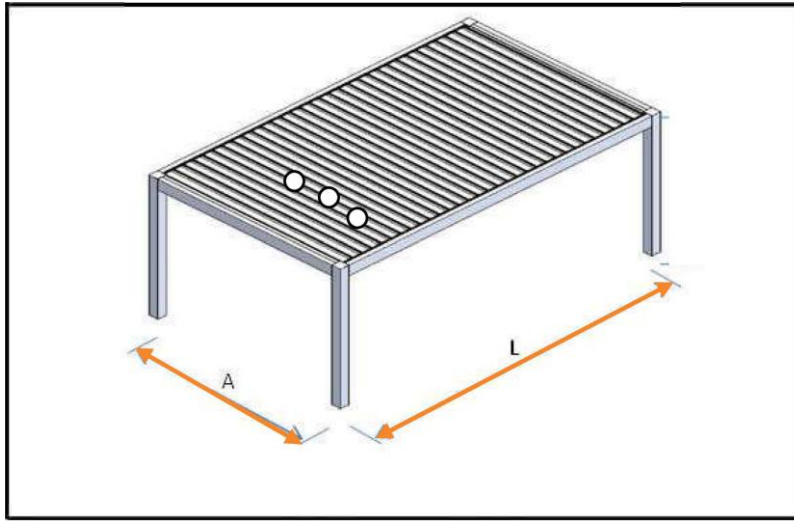
Impactor	Impact height of 0,45 m	Remarks	Result
0,5 Kg Steel ball	First impact	No damage visible	SATISFACTORY
0,5 Kg Steel ball	Second impact	No damage visible	SATISFACTORY
0,5 Kg Steel ball	Therst impact	No damage visible	SATISFACTORY

Image 2. Location of hard body impact points.

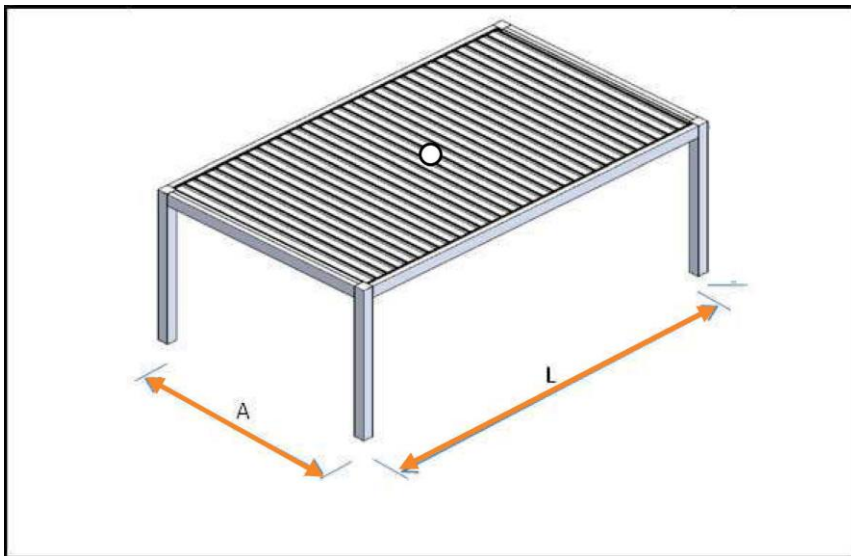
Impactor	Impact height	Remarks	Result
50 kg bag	1,2 m	No damage visible	SATISFACTORY

Image 2. Location of hard body impact points.

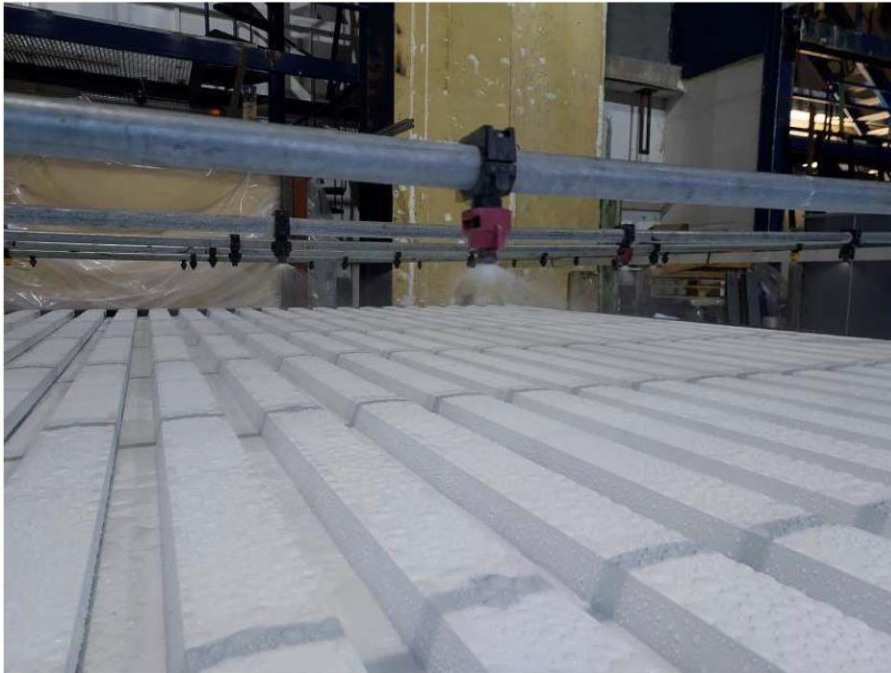
Water Flow rate applied	Duration of spraying	Remarks	Result
0.82 l/s	60 minutes	No damage visible	SATISFACTORY

Photo 3. Photograph taken during the watertightness test.

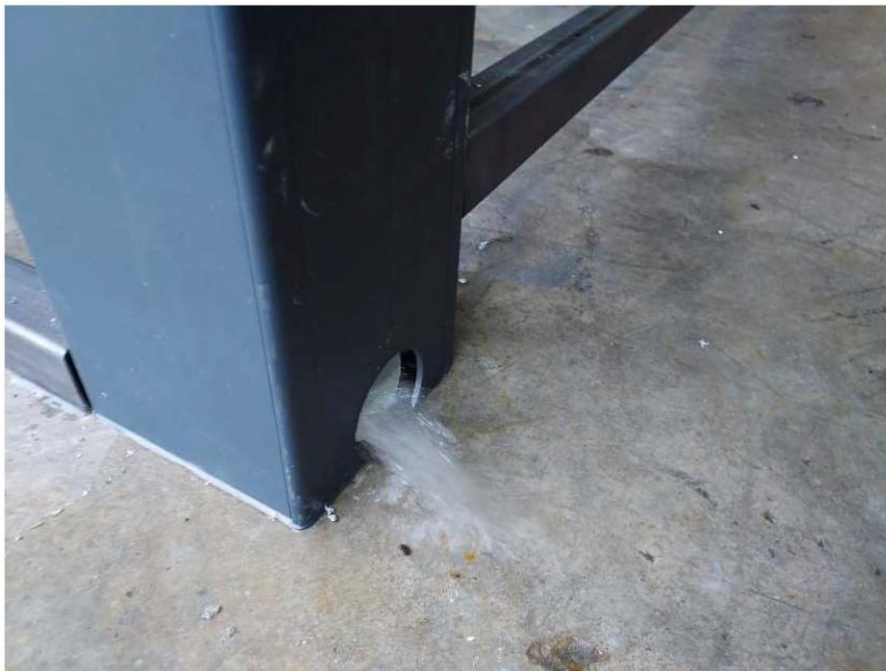
Photo 4. View of the drainage system during the watertightness test.

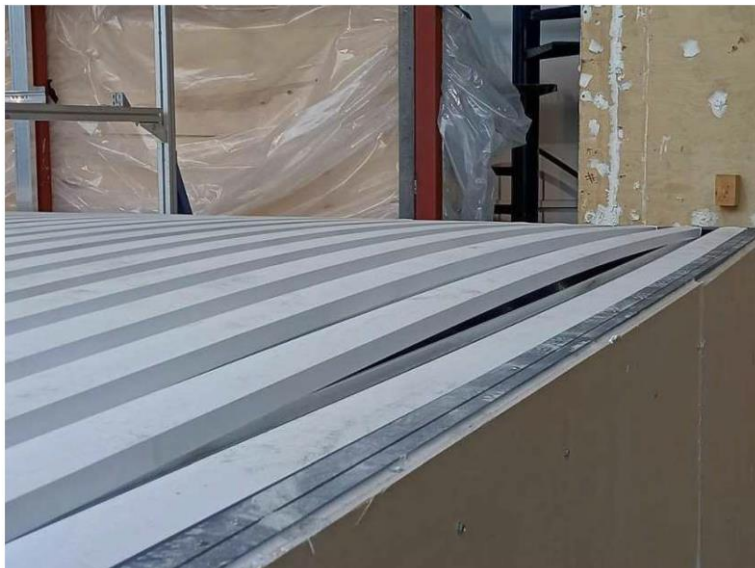
Up to 2,400 Pa, the sample shows no apparent damage to the naked eye. Before reaching 2.600 Pa, the louvers come out of the guides.

Photo 6. Sample failure before reaching 2600 Pa of suction.

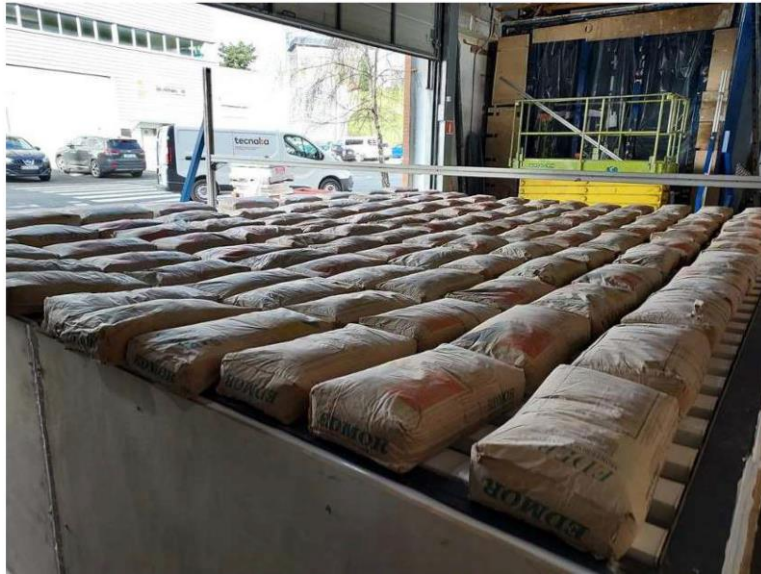
Applied load	Duration of test	Remarks	Result
2.970 kg	10 minutes	No damage visible	SATISFACTORY

Photo 7. Photograph taken during the snow load resistance test.

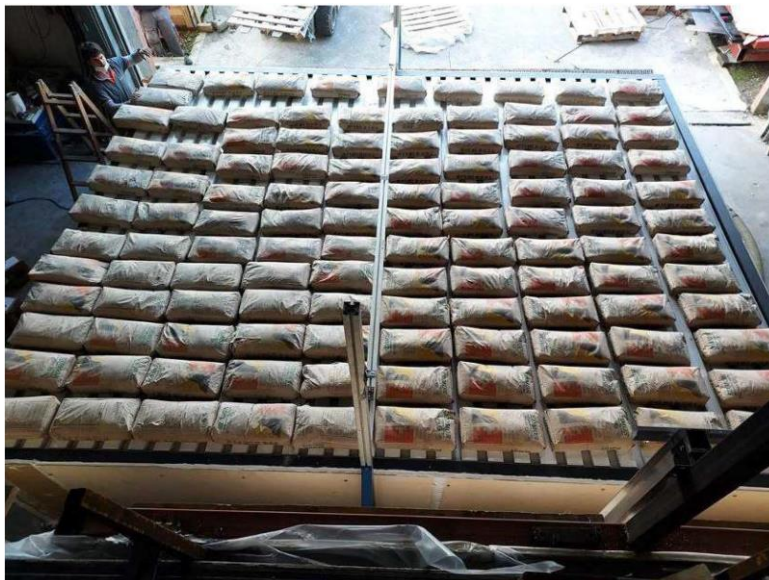
Photo 8. Photograph taken during the snow load resistance test.
